# **TOWN OF GERALDINE, MONTANA**

## **Phase 1 Water System Improvements**

Technical Memorandum

January, 2022

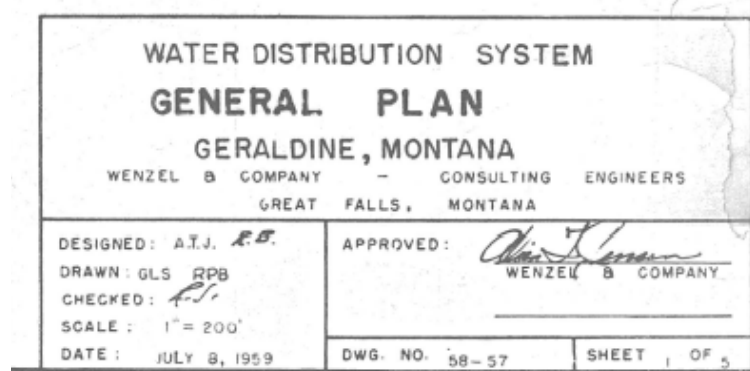
- Old/outdated piping – The vintage of the existing AC piping is from the 1950s based on available Town as-builts. Water system retrofits, tie-ins, and improvements require tapping into and adapting new piping to the existing AC mains. The dissimilar piping connections between the AC and PVC (or other) newer piping/fittings creates weak points where future leaks or ruptures are regularly occurring in the Town. Figure 1 shows the title block drawing date of the system as 1959. A full copy of the distribution system record drawing is found in Attachment A.

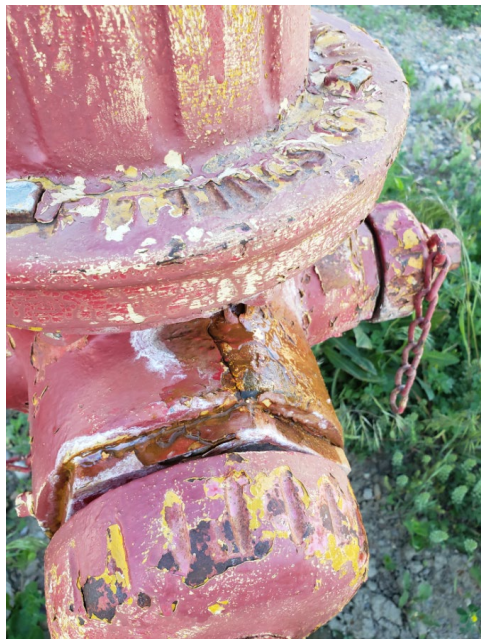
- Outdated and Leaking Fire Hydrants - The existing fire hydrants are old and are evidenced to be leaking. The fire hydrant leads are only 4-inch and do not comply with DEQ standards. The fire hydrants connected to the 3 and 4-inch AC piping were also installed in the 1950's. Several hydrants are observed to be leaking or even cracked. (See Figure 1 below for a typical cracked and leaking hydrant)

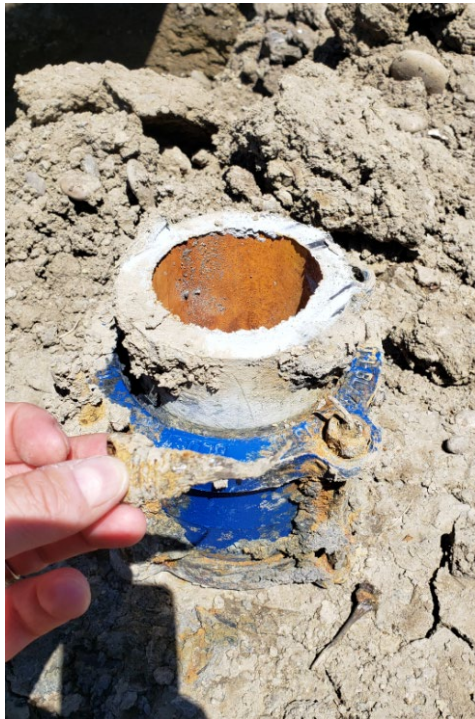
**Figure 3 - Removed coupler to AC main (notice completed corroded bolt in the hand)**

- Corrosion on metal fittings - The metal fittings and bolts installed within the existing water system fittings have been subject to corrosion. The corrosive soils are causing leaks at exposed metallic bolts and fittings, which then serve as potential entry points for contaminants. Corrosion of

existing metallic bolts and fittings has been observed when encountering the water line during the most recent sewer project. Figure 2 shows an existing bolt extensively corroded with all threads worn down on a coupler fitting in 2021.
