Geraldine Phase 2 Funding Options

Options for Phase 2

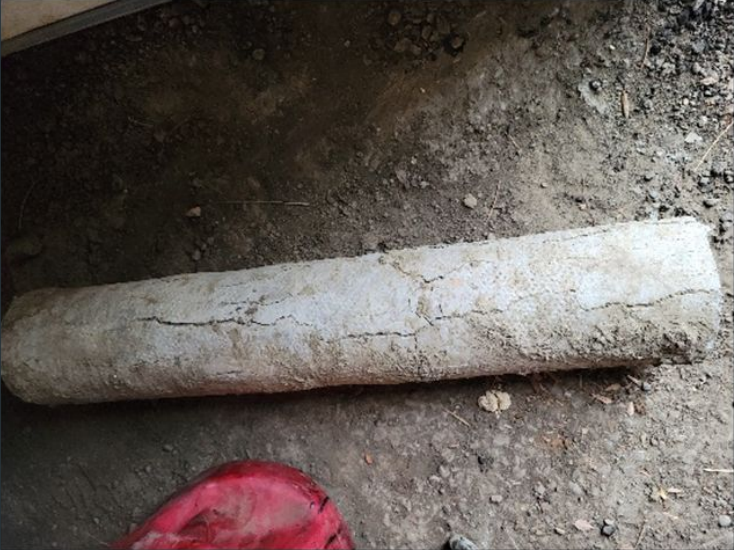
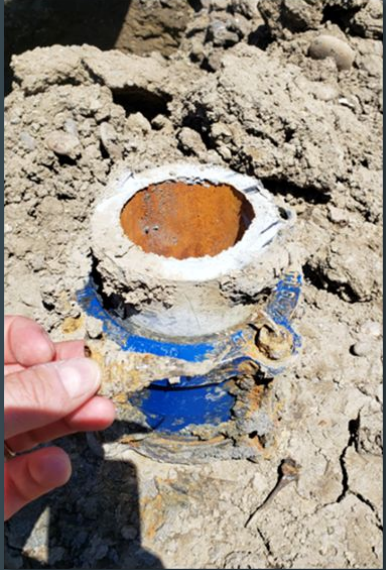
Leaking and Problematic AC Water Distribution Mains and Fittings – The Town’s distribution system is comprised mostly of AC pipe that is 4- inches or smaller in diameter. These pipes and fittings were installed in the 1950s and some sections earlier, and the system is operating well beyond its useful service life. The piping experiences significant leaks as well as water main breaks. Water loss in the system can be up to 50%. The suspected causes for the leaking are the age and degrading condition of the pipes and weak connection points. Documented longitudinal cracks are propagating along sections of this piping. Leaky water main piping presents a significant health hazard due to the potential for contamination from backflow events.

Corroded and Inoperable Water Valves – Another source of leaking in the water system are the old water valves and metallic fittings that have corroded severely. In addition to leaking, many of the gate valves in the system no longer function to fully close the lines. The lack of useful valves has prevented the Town from being able to isolate small sections of the distribution system for maintenance and repair. Instead, large portions of the system, if not the entire town, instead of the single Town block being worked on, need to be shut down during leak repairs and often with little or advanced notice to the residents due to emergency repairs. The soils are documented to be corrosive. The inability to isolate specific portions of a system is out of compliance with DEQ standards and poses a higher risk for potential pathways for contaminants to enter the water system when larger sections of mains are depressurized.

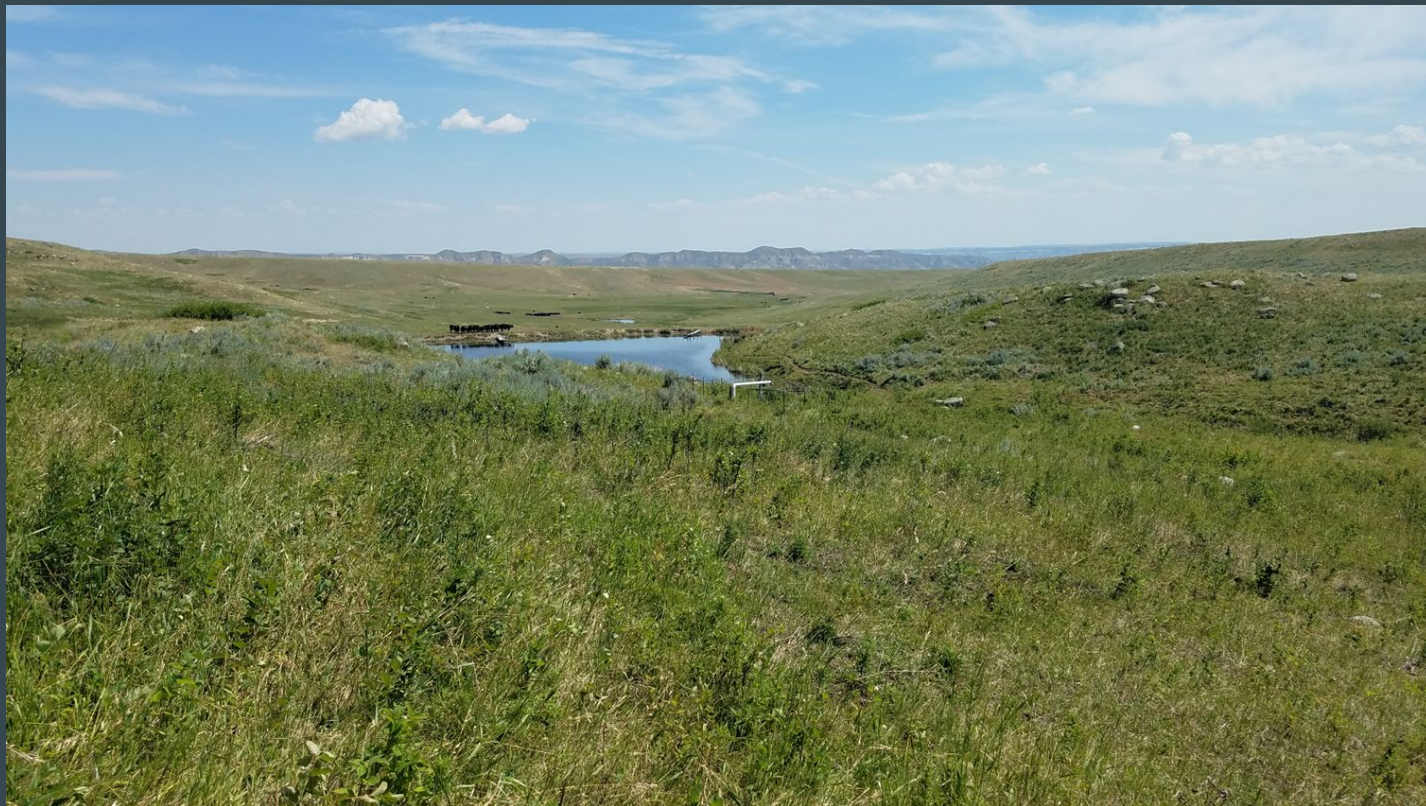
SPRING GALLERY VIEW TO EAST

Potential for Surface Water Infiltration at Spring Site - Spring water is considered groundwater not under the direct influence of surface water. However, the documentation suggests the spring collection galleries were not constructed with an upper membrane or impermeable materials to effectively inhibit surface water infiltration. Spring water not captured by the collection galleries flows overland across the spring development as surface water and can infiltrate groundwater. In addition, ground settling above the collection galleries has produced some surficial depressions which can retain surface water/snow melt, providing increased potential for surface water contamination of the spring collectors. This situation can be the cause of past total coliform and e coli deficiencies.

Vegetation and Soil above Spring Galleries - The springs are relatively lush areas with abundant plant growth and a developed organic soil profile. Excessive vegetation provides habitat for rodents, and plant roots can cause clogging of spring collector piping over time. Organic-rich soils can increase concerns for bacterial contamination of the spring water collection system.

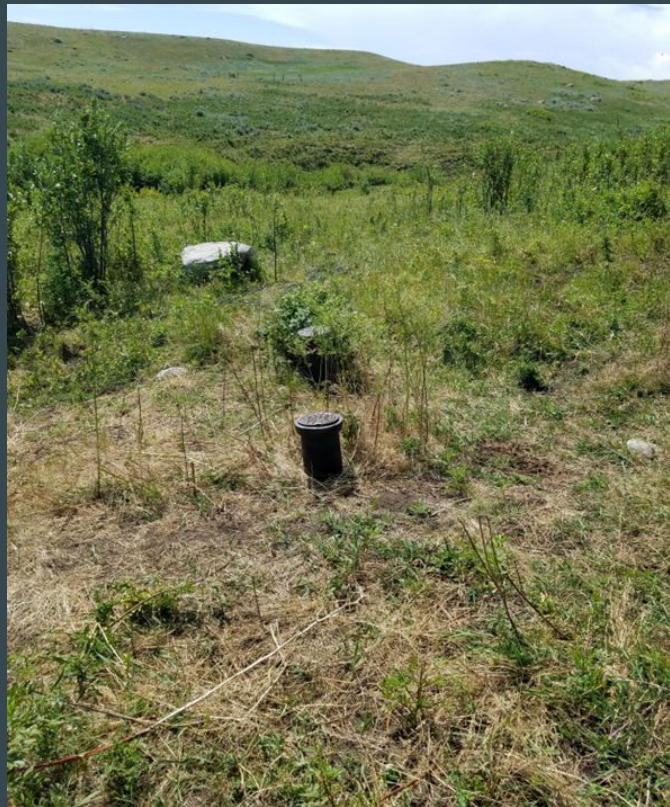
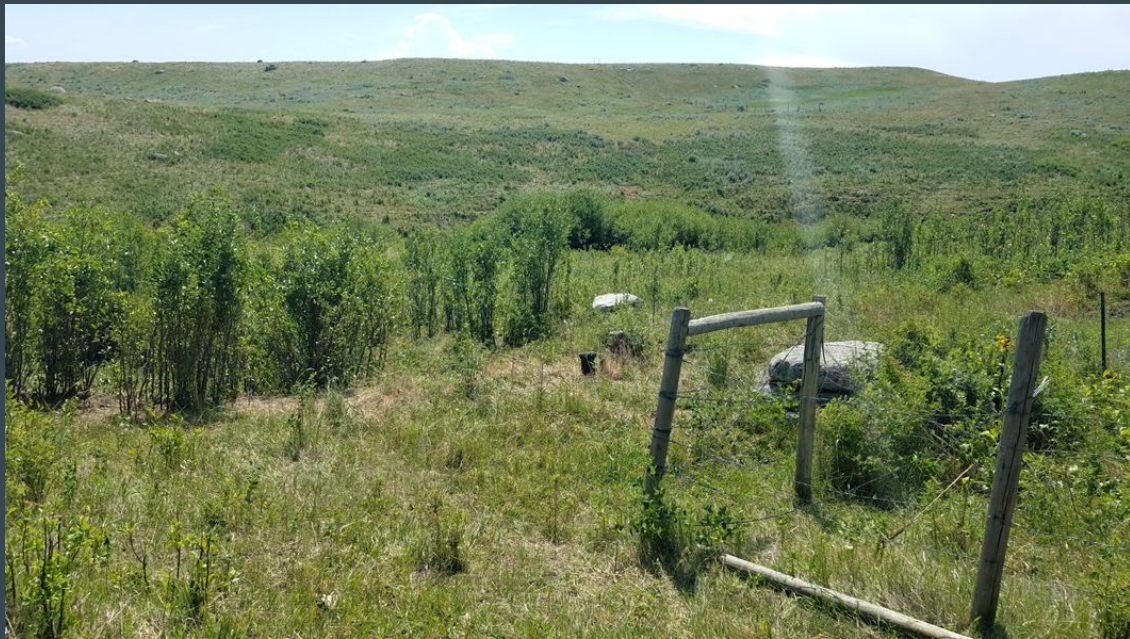
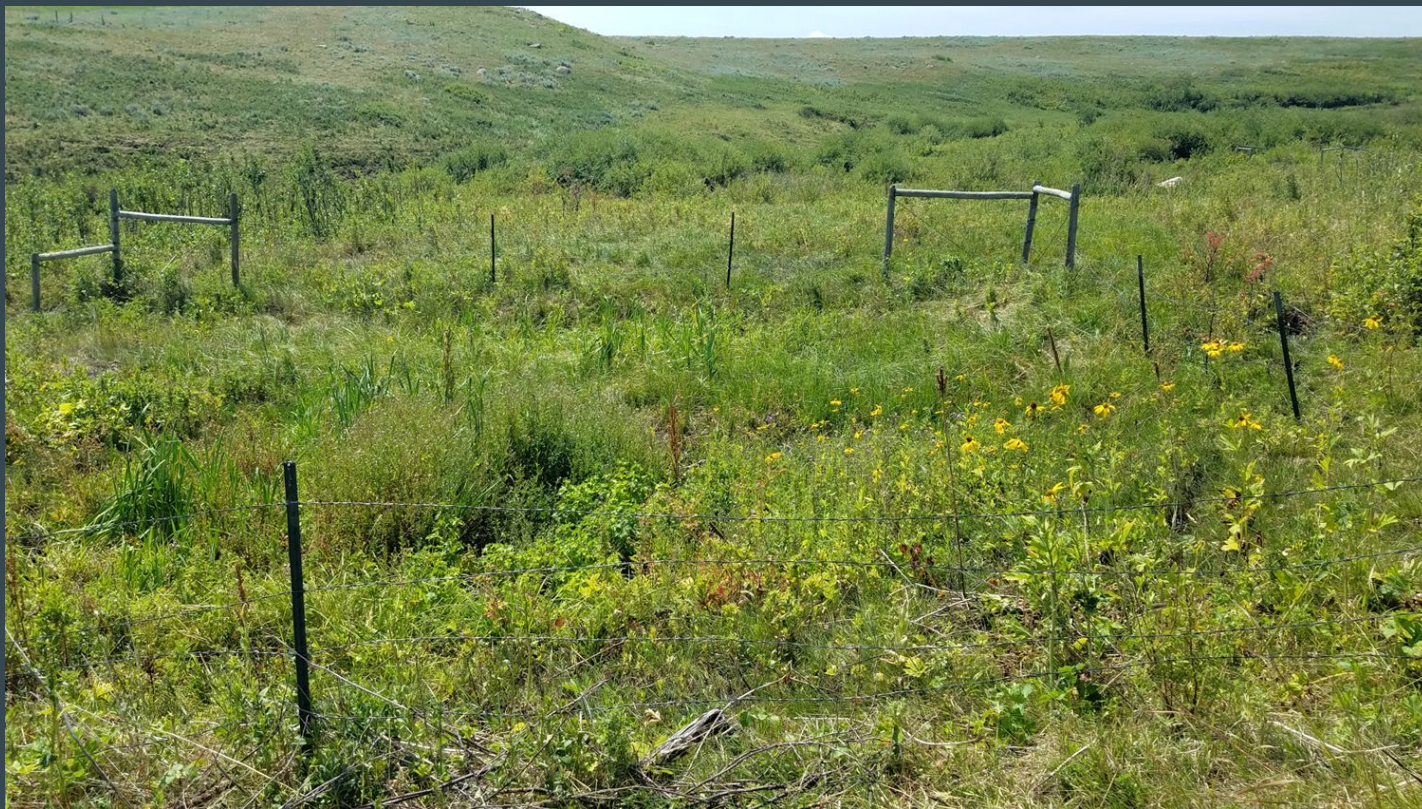
Springs

Spring Ground Movement - The springs occur within a mapped alluvial landslide deposit. Slow ground movement is observed to affect surficial spring collection features; valve boxes, vault structures and fencing are exhibiting dislocation and settling impacts. Ground movement has caused some valves to be inaccessible and has buried by-pass outfall pipes. It is unclear at this time to what extent ground movement may be affecting the sub-surface spring collector piping.

Spring Source Contamination Concerns – Livestock and game activity in and around the springs poses a threat to spring water quality. The immediate area around each of the spring galleries is fenced, however, the areas have inadequate protection from cattle-born or game fecal contamination of the larger springs footprint. The system has also received past violations for fecal positive testing showing the susceptibility of contamination of this source location.

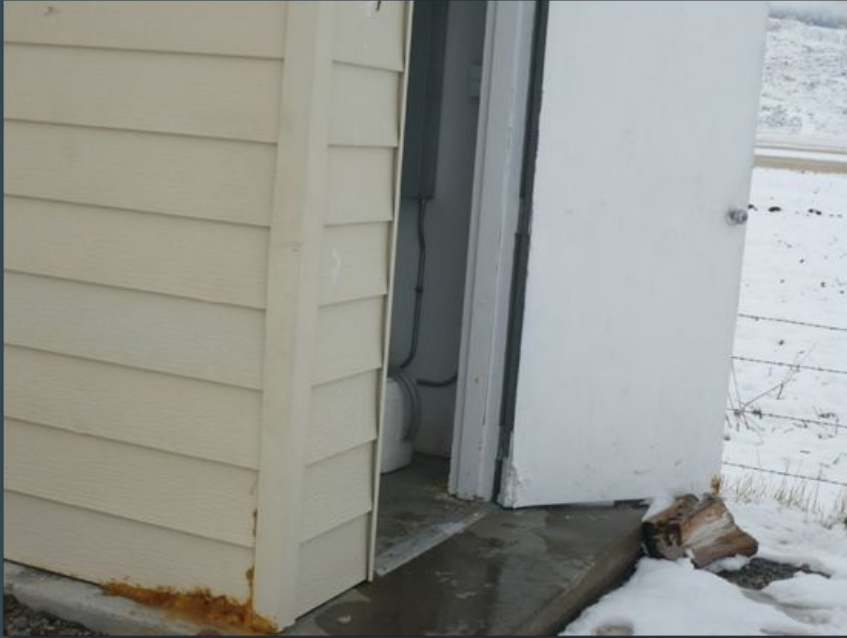
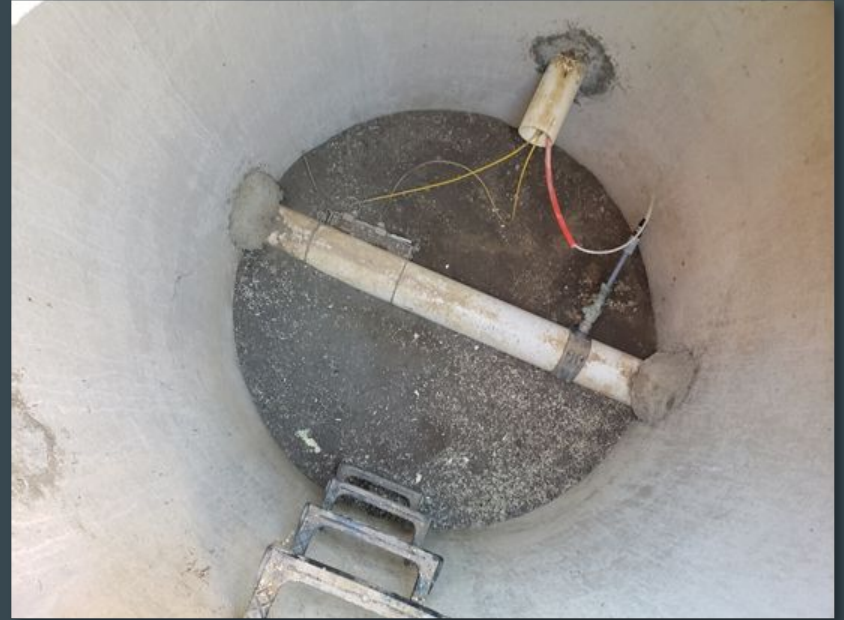
Treatment Building

Unsafe Chlorination Station – The water system receives disinfection through a chlorination station using liquid sodium hypochlorite at an injection point located north of the springs. The vaults that contain the flow meter and injection equipment are in tight and confined spaces, and the Town's workers are unable to easily and safely operate and maintain the equipment. Replacing the chlorine injectors can be extremely difficult in the existing tight working area within the 48-inch manhole vaults. Additionally, the building that houses the chlorination equipment has begun to deteriorate to a state which allows rodents and other vermin access to the chlorination equipment space.

- 2 Vaults (Confined Space)
- Degrading/Corroded Shed Space
